**Archimedes Screw Turbine Fisheries Assessment.
Phase II: Eels and Kelts.**

Client: Mann Power Consulting Ltd.

March 08

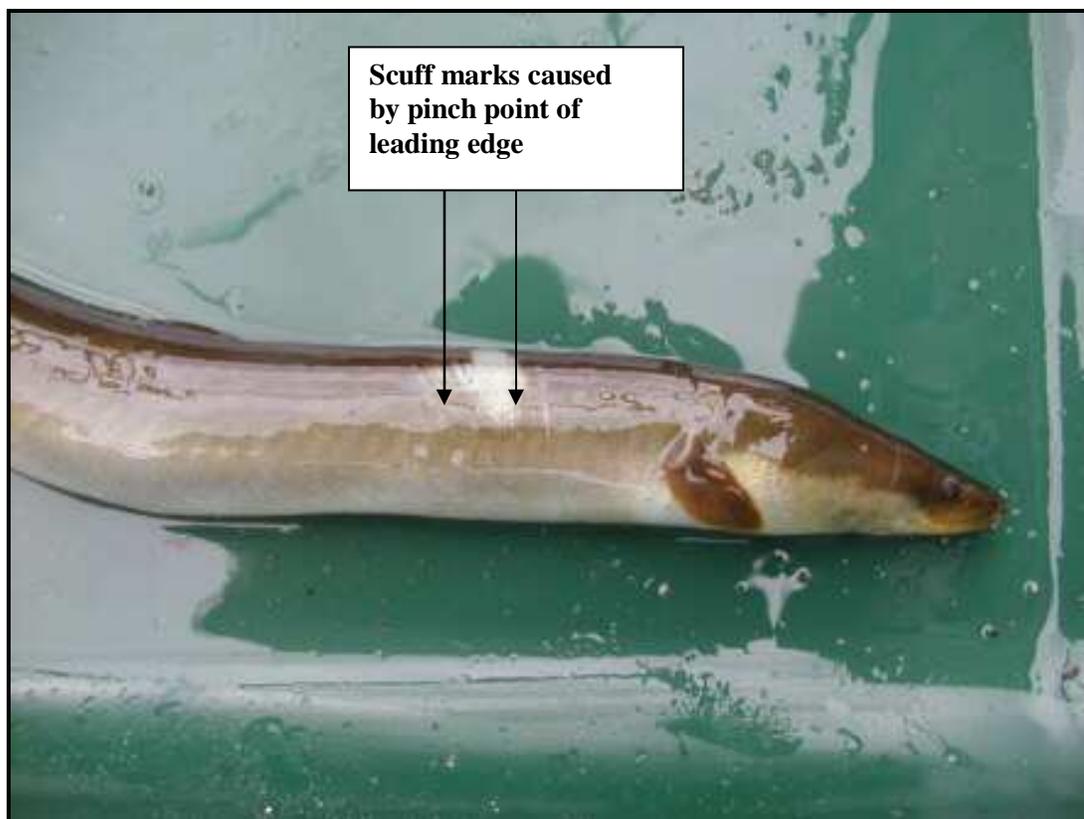
The results are shown in table 1. One out of a total of 12 eels (8%) suffered a severe pinch mark behind the head and a damaged spine, see figure 3. It is unlikely the eel would have survived long term. The scuff marks on the skin suggested that the eel had been trapped by the overhang of the leading edge, shown in figure 4. Placing the eel under the overhang confirmed this, as it fitted exactly into the 20mm gap.

Figure 3. Eel caught in pinch point

Before continuing with the trials, it was decided to modify the edge by cutting it back so it ran within the trough, removing the bevel and pinch point. The modified leading edge is shown in figure 5.

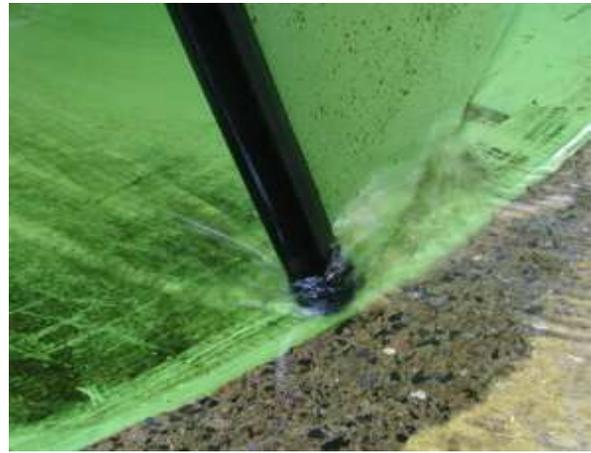
Figure 5. Modified edge

It was evident that modifying the leading edge had resolved the issue of eels being trapped and damaged by the pinch point. This was confirmed by a Chi-squared comparison of results before and after modification. (Chi-squared test, $p=0.02$).

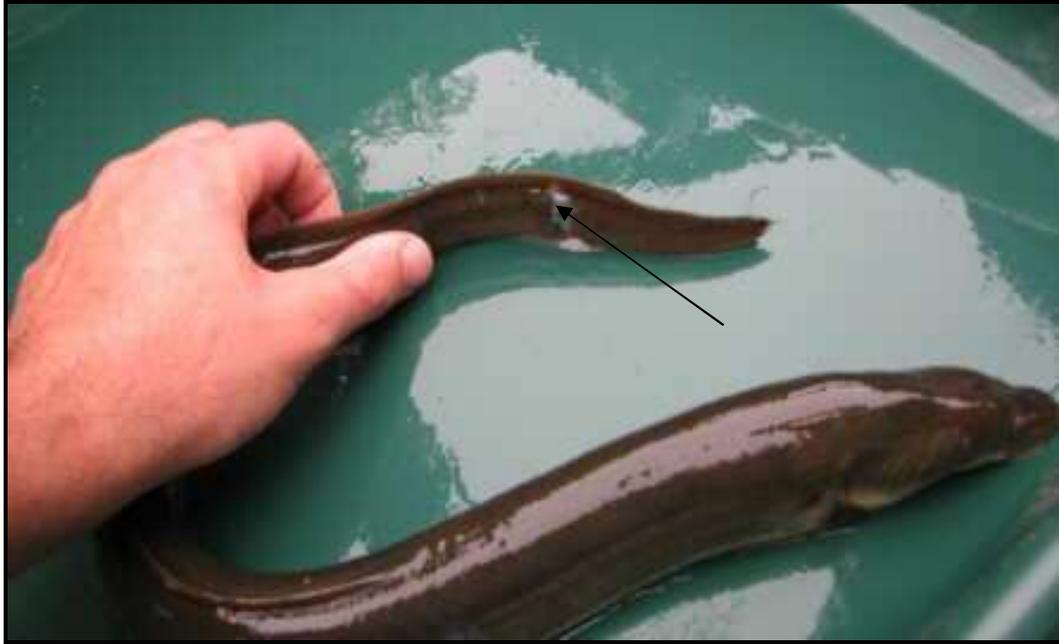
160 passages through the turbine were recorded across a range of speeds as shown in table 2. One eel suffered minor damage in the form of a pinch 5cm from the end of the tail (see figure 8), probably caused by the tail sliding under the 5mm gap between the screw helix and the trough. All the eels were alive and appeared healthy after 7 days in holding tanks. The damaged eel was observed for a further 7 days (14 days in total) after which it was released into the river. It was concluded that the damage to the tail was recoverable and the risk to eels from passing through the screw negligible. Overall the mortality rate was 0%, with less than 1% (0.64%) suffering minimal and recoverable damage.

Figure 8. Eel with pinched tail

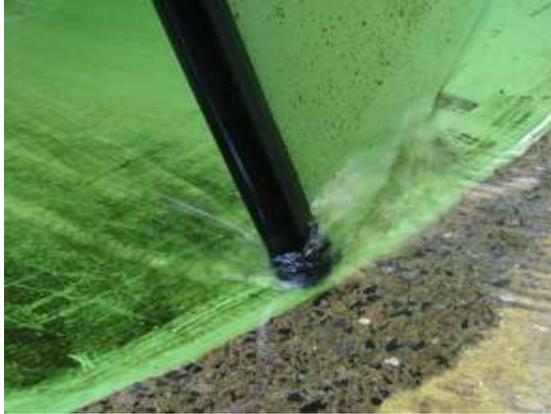
Rubber extrusion (fish bumper) after fitting

The leading edge must be modified by removing the bevel and any overhang of the trough. Extruded rubber profiles (fish bumpers) should also be fitted to protect larger fish in particular. While the bumpers are extremely durable, they should be inspected during routine maintenance, every 6 to 12 months.

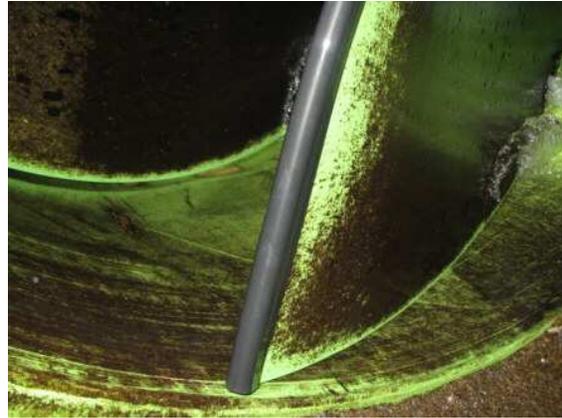
The bumpers fitted to the leading edge were assessed after 8 months of continuous operation. They were in perfect condition (see appendix) and could be expected to last for 5-10 years.

After 8 months of operation
