**Archimedes Screw Turbine Fisheries Assessment.
Phase II: Eels and Kelts.**

Client: Mann Power Consulting Ltd.

March 08

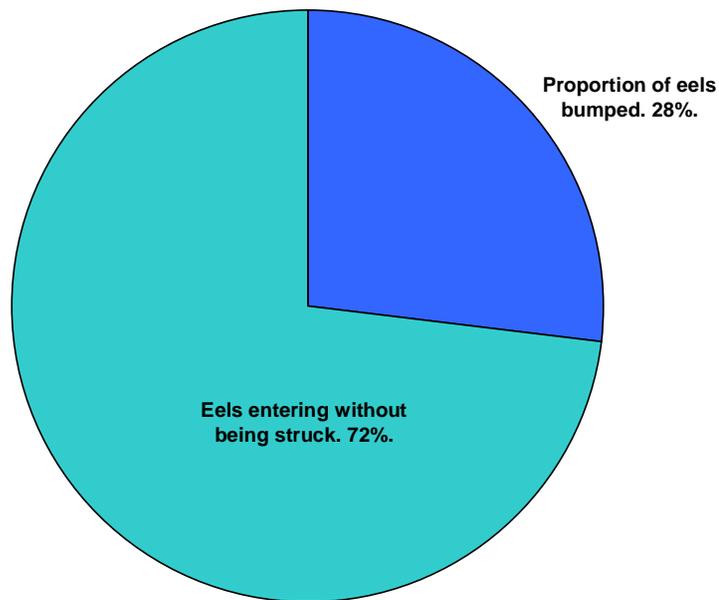
Figure 9. Proportion of eels struck by leading edge

Eels entered the turbine along the floor of the forebay tank as expected. The majority passed through without being bumped by the leading edge, approximately 28% were struck, as shown in figure 9. No damage was inflicted, suggesting that the maximum speed of 3.8m/s towards the periphery of the helix is too low to cause injury.

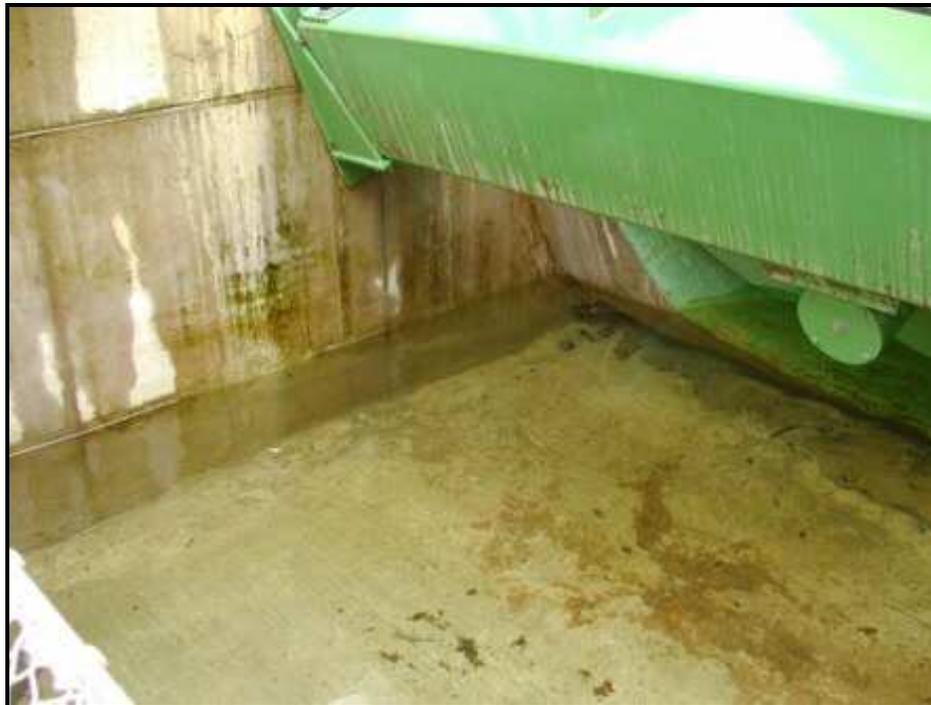
Figure 11. Trap at the outflow box

A grid of 50mm x 50mm weld mesh formed a holding area to trap fish in the outflow box, see figure 11. The trap was checked every morning and evening. Fish were assessed for turbine induced damage, such as scale loss, strike marks from the leading edge and haematoma. They were photographed, weights and lengths recorded and then released.

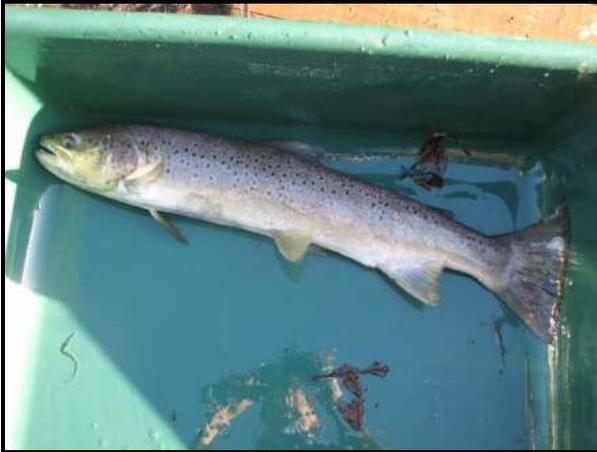
Figure 13. Sea trout kelt.

While none of the fish were damaged by passing through the screw, some were in poor condition, with bacterial/fungal lesions and fin rot. This is not unusual, especially for spring run fish that may have been in the river for at least 6-8 months. One of the smaller sea trout kelt and a 77cm salmon kelt are shown in figures 13 and 14 below.
